INTERSTATE COMMERCE COMMISSION
WASHINGTON

ACCIDENT ON THE
PENNSYLVANIA RAILROAD

VAN WERT, OHIO

INVESTIGATION NO. 2272

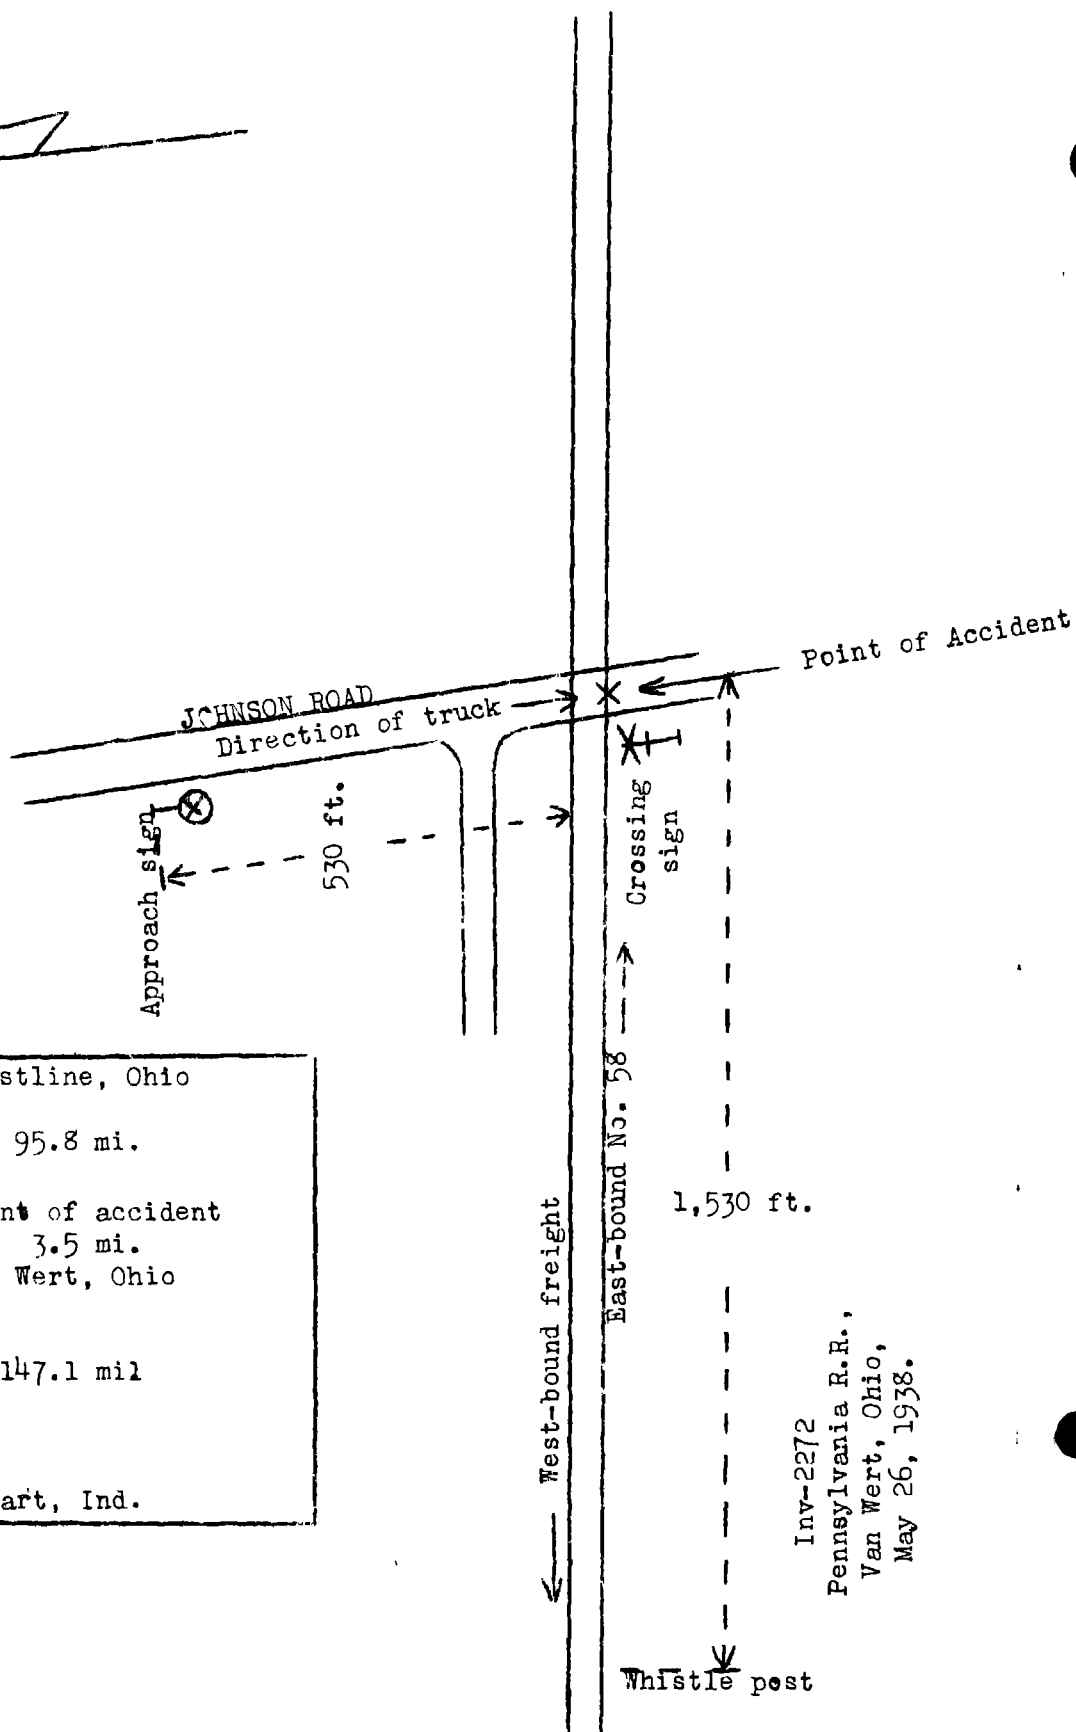
Inv-2272
Pennsylvania R.R.,
Van Wert, Ohio,
May 26, 1938.

• Crestline, Ohio
95.8 mi.
* Point of accident
3.5 mi.
• Van Wert, Ohio
147.1 mil
• Hobart, Ind.

Johnson Road extends north and south and varies in width from $15\frac{1}{2}$ feet at the crossing to 22 feet at a point 530 feet north thereof. It is macadam surfaced; at the crossing, however, it is constructed of tarvia and is in fair condition. Approaching from the north the highway is tangent, and it is approximately level to a point 100 feet north of the north rail of the westward track, from which point it ascends to the level of the tracks, the total rise being 4 feet. This crossing is protected by an approach sign located 13 feet west of the center line of the highway and 530 feet north of the north rail of the westward track. It is a yellow disc, 28 inches in diameter, 5 feet above the level of the highway, with a cross-bar and the letters "R R" in reflector buttons. A standard cross-buck sign, bearing the words "RAILROAD CROSSING", with a horizontal bar below bearing the word "DANGER", is located at the southwest corner of the crossing, the top of the post being 9 feet 6 inches above the top of the rail.
